New York State Department of Transportation

PIA Safety Flag NB23U4W009

BIN: 1065318

Feature Carried: 278I278IX2M23027

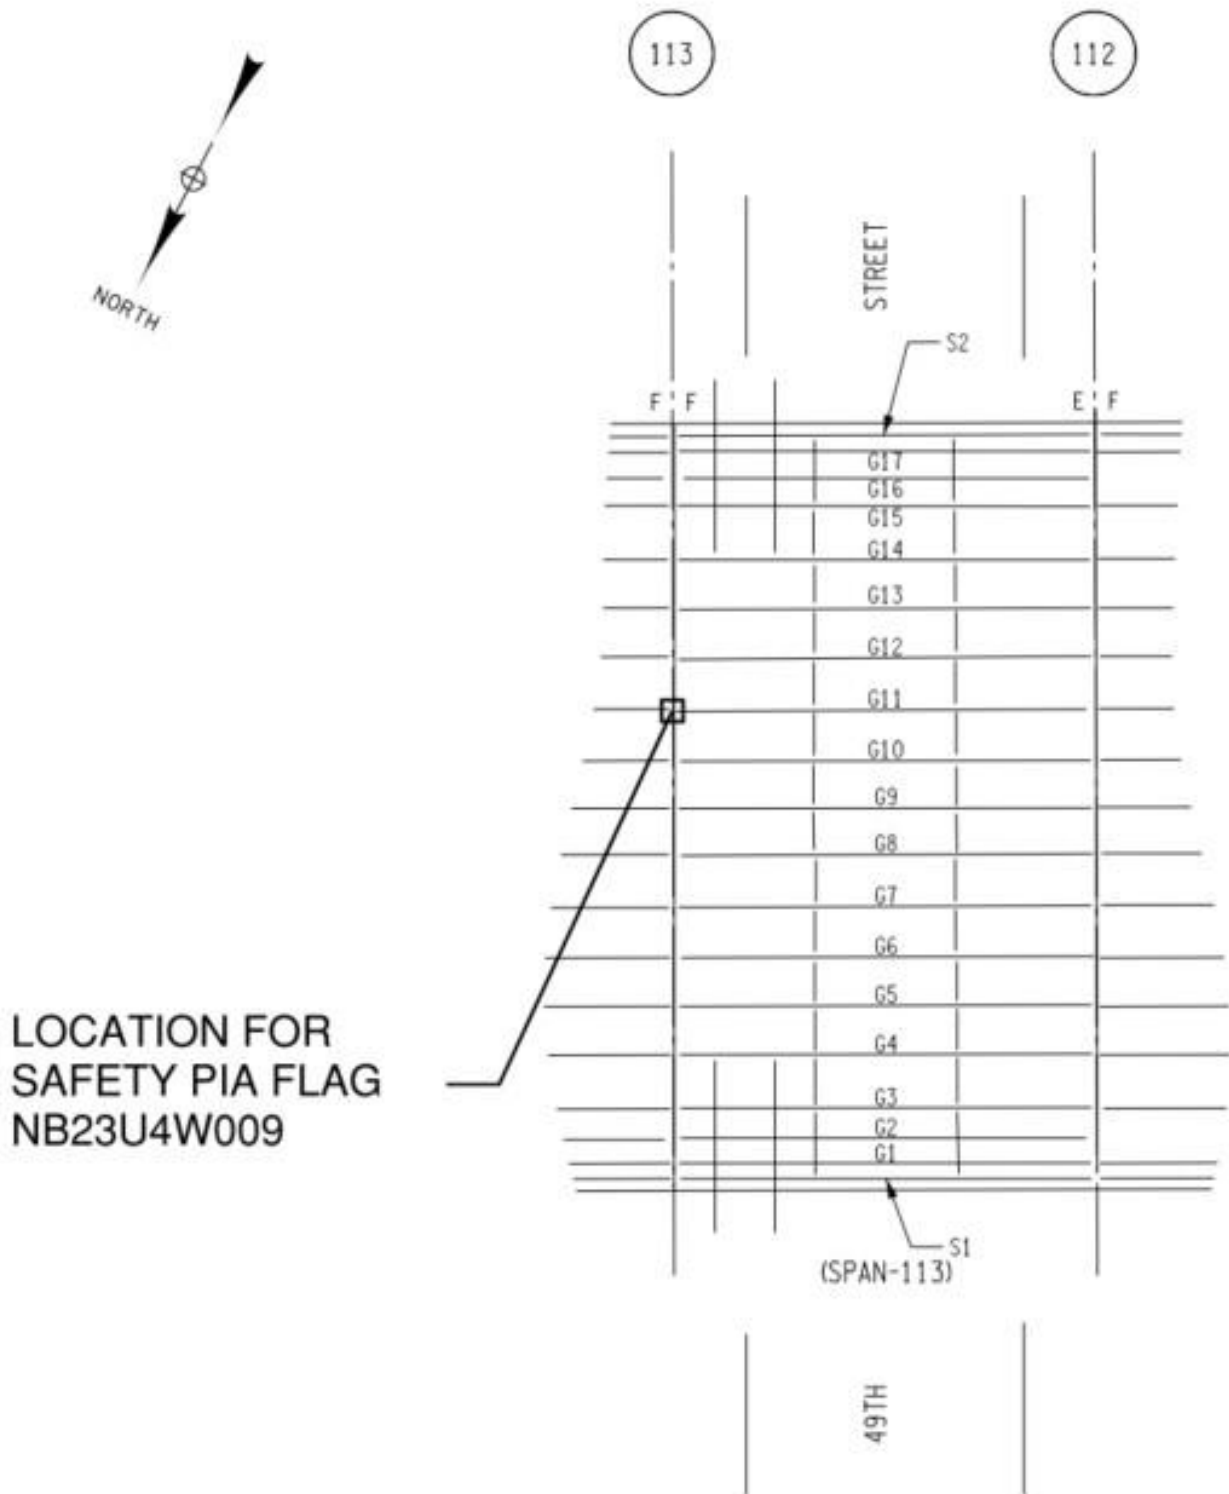
Photo Number: 1

**Attachment Description: Safety PIA Flag Location**

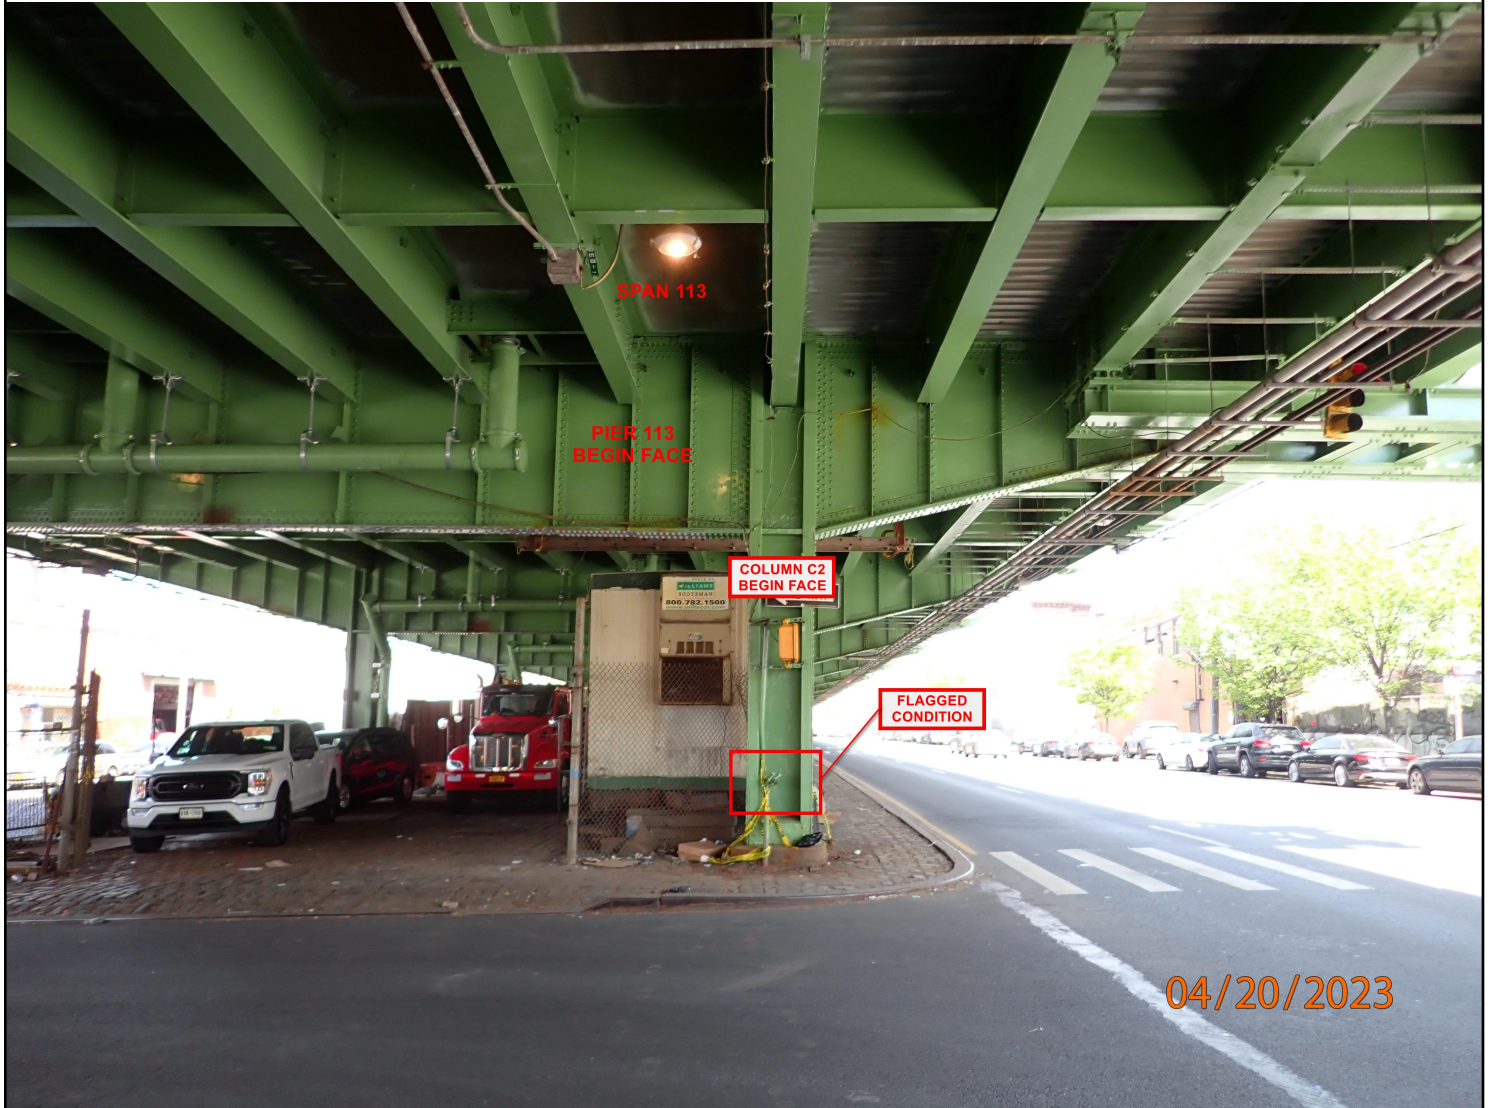
Photo Number: 2

The junction box for the traffic light and attached to Column C2 is broken with exposed electric wires. This location is located at 3' above the ground on the sidewalk and can be accessed by walking. The area is temporarily secured with cones and caution tape.

Attachment Description: General view of the flagged condition under Span 113, Column C2 at Pier 113. Looking End.

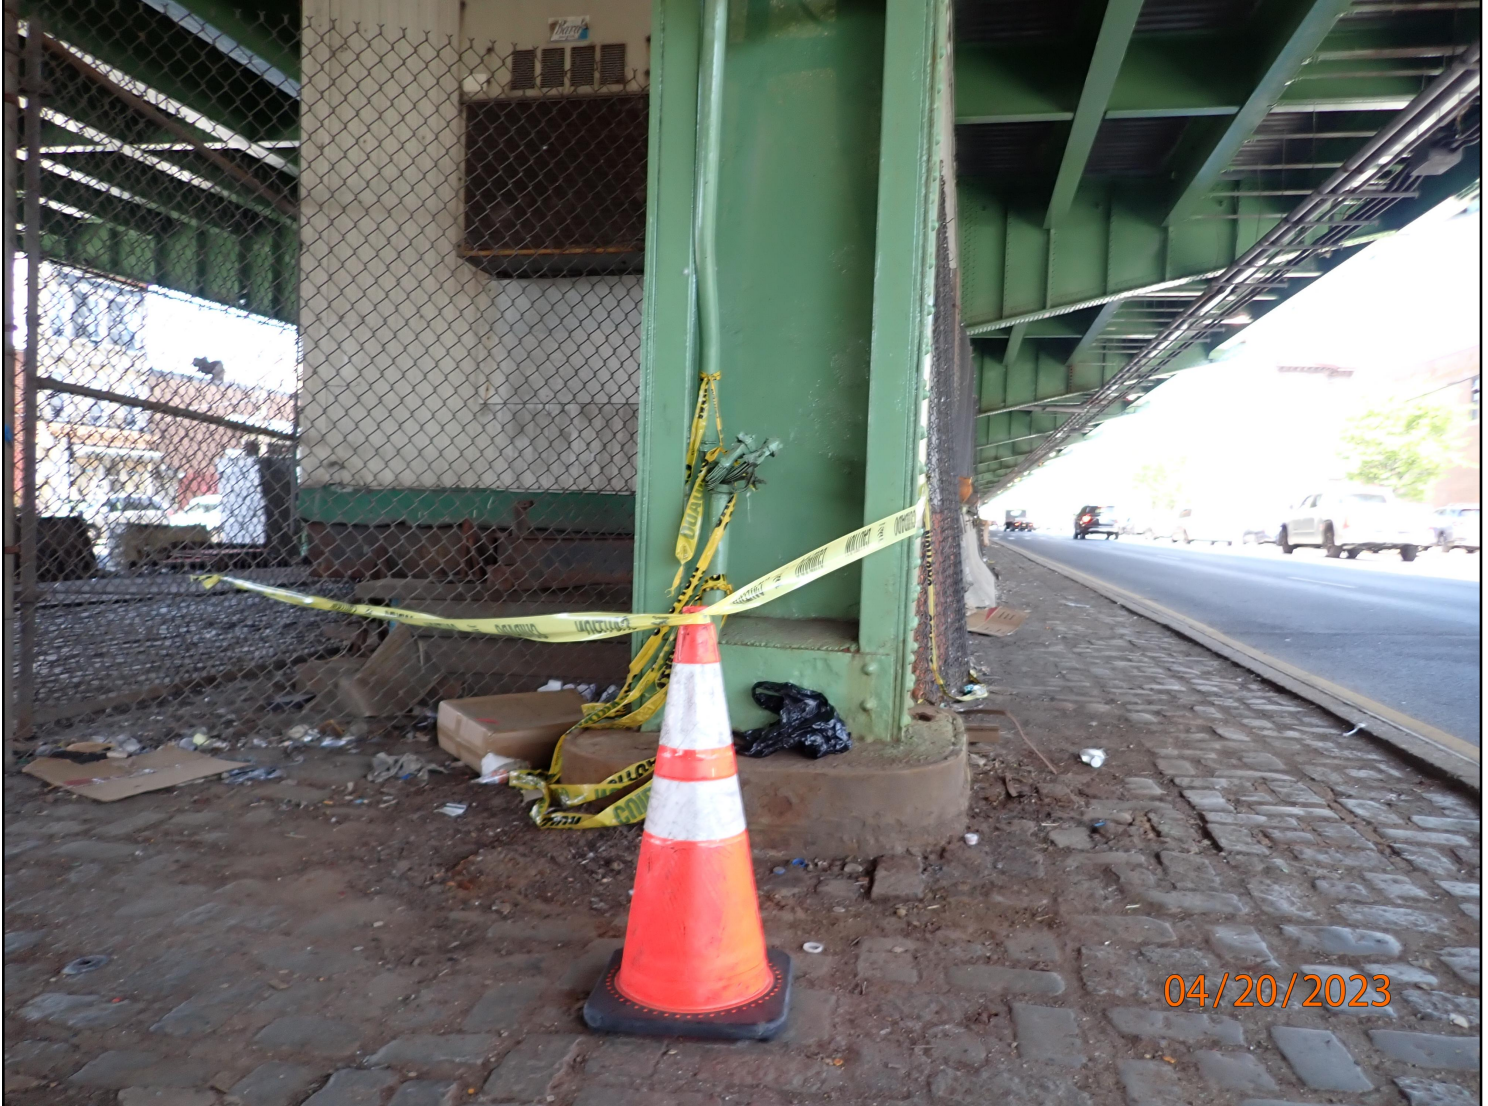
Photo Number: 3

Attachment Description: The sidewalk at the begin face of Column 2 of Pier 113 under Span 113. The electrical junction box is broken with exposed wires. The area has been coned off with yellow caution tape. Looking End (left).

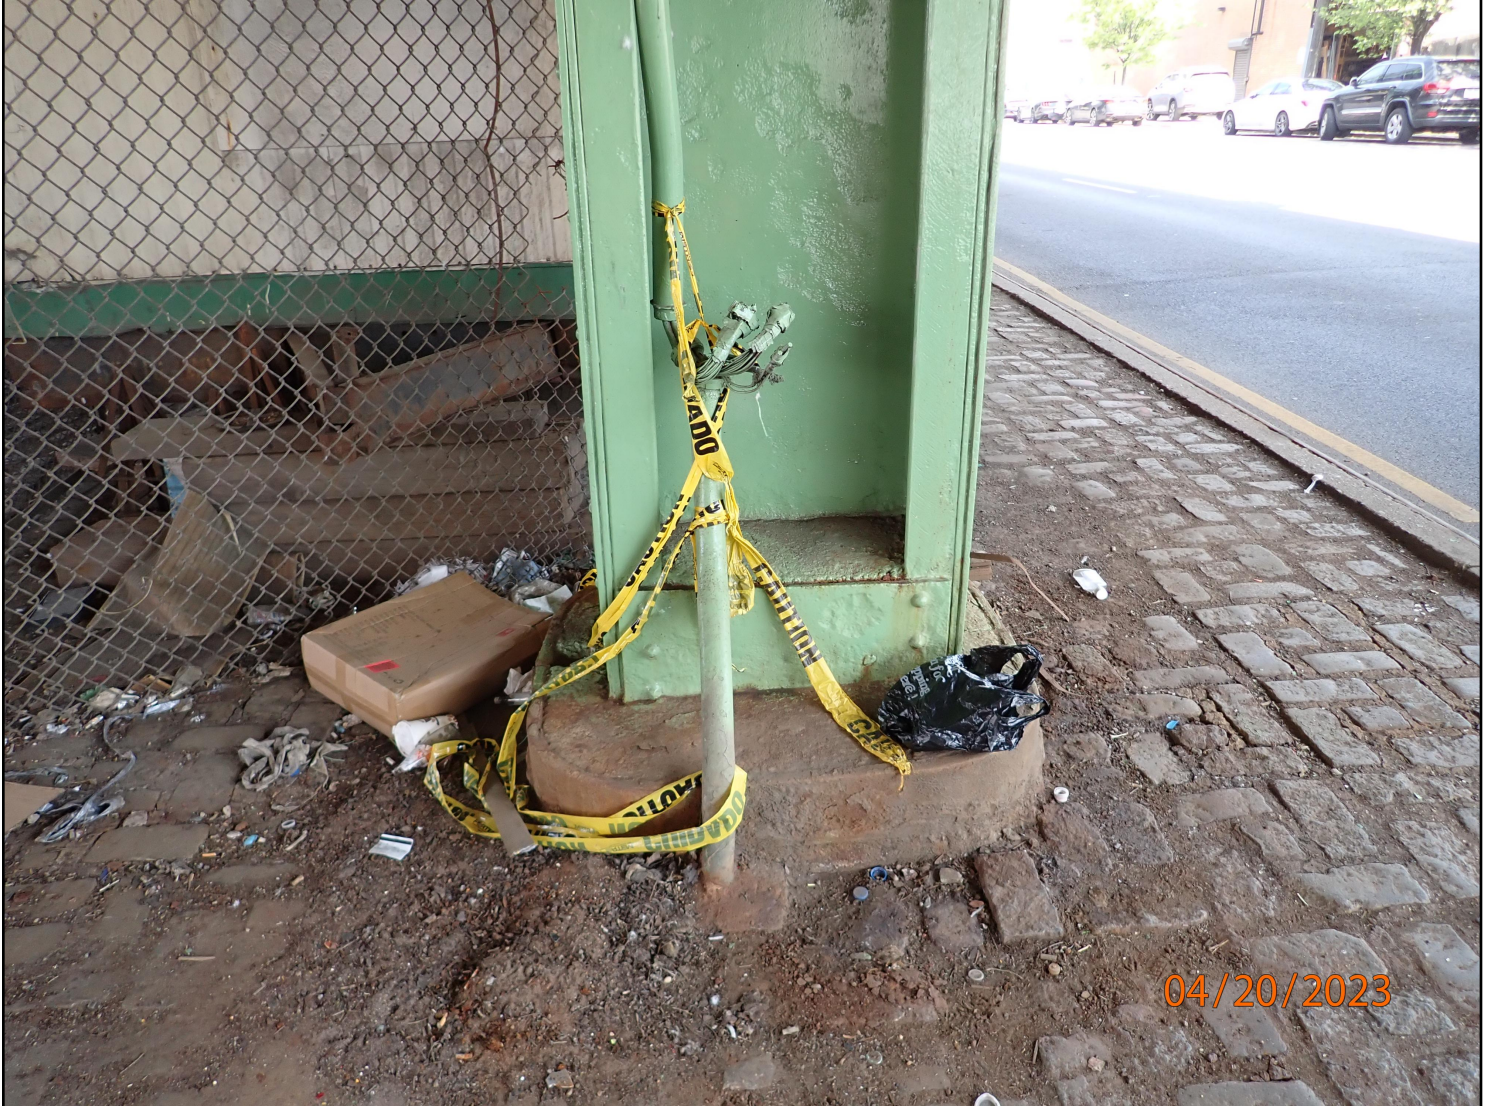
Photo Number: 4

Attachment Description: The sidewalk at the begin face of Column 2 of Pier 113 under Span 113. The electrical junction box is broken with exposed wires. The area has been coned off with yellow caution tape. Looking End.

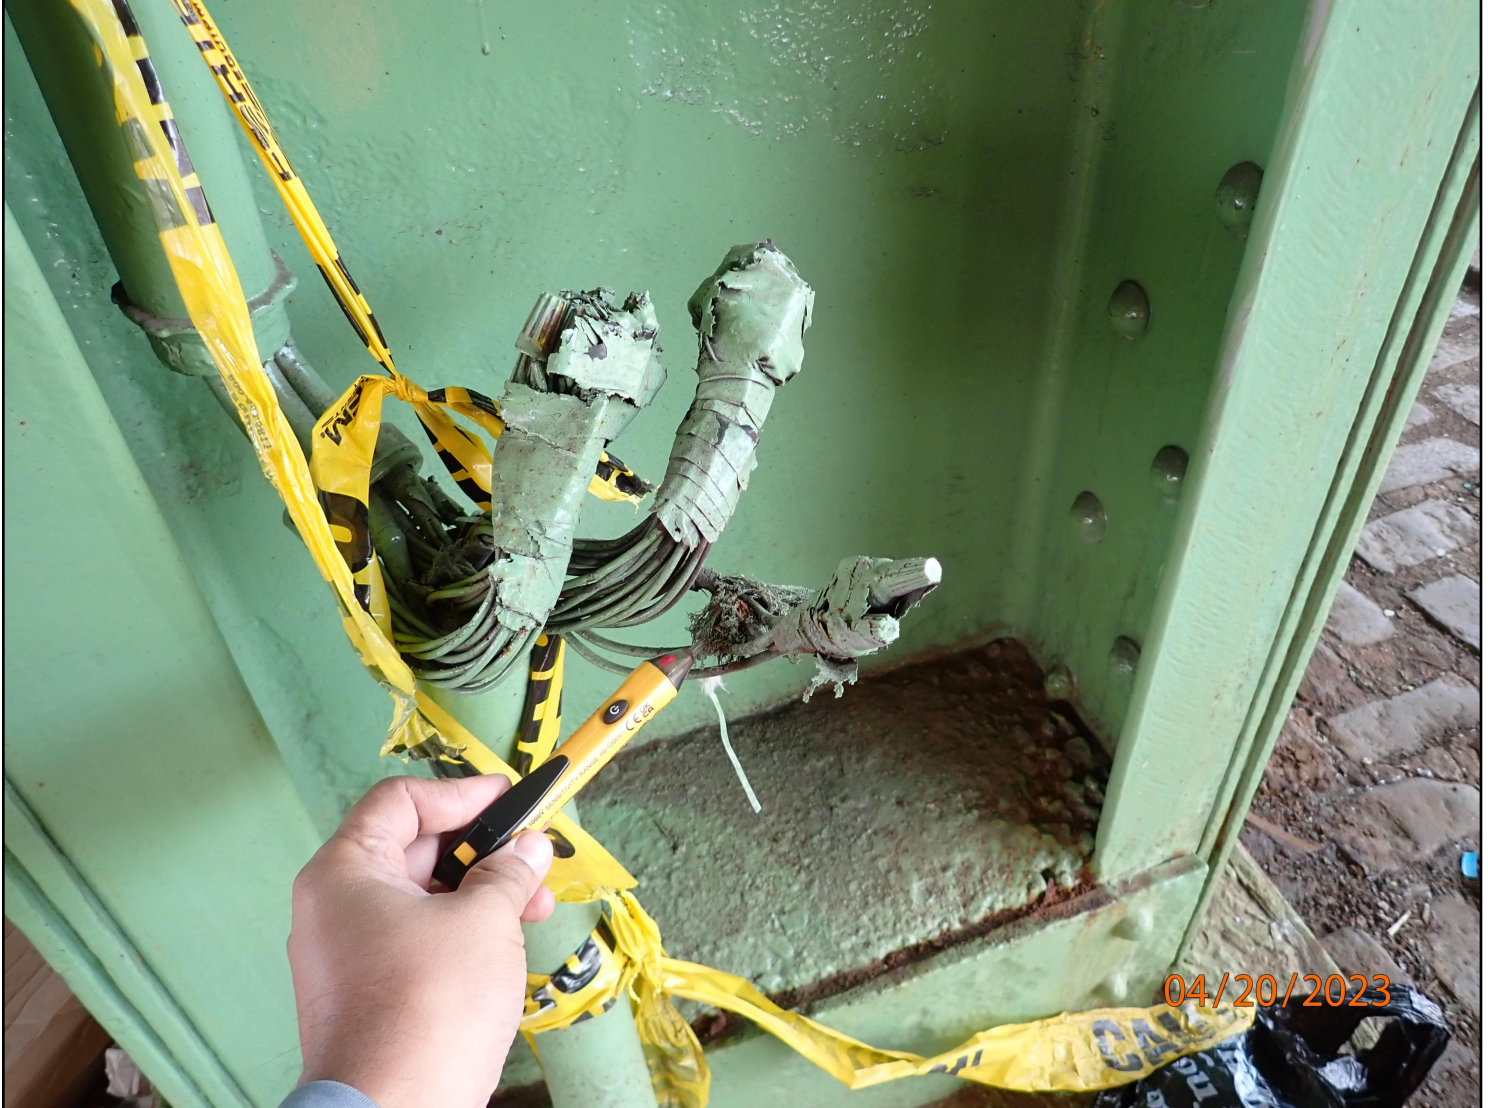
Photo Number: 5

Attachment Description: The sidewalk at the begin face of Column 2 of Pier 113 under Span 113. The electrical junction box is broken with exposed wires. The area has been coned off with yellow caution tape. Looking End-Right.
